*Certification Docket for the  
Remedial Action Performed  
at the General Motors Site in  
Adrian, Michigan*

*Department of Energy  
Office of Assistant Manager  
for Environmental Management  
Oak Ridge Operations*

*January 2001*

CERTIFICATION DOCKET  
FOR THE  
REMEDIAL ACTION PERFORMED AT THE  
GENERAL MOTORS SITE  
ADRIAN, MICHIGAN

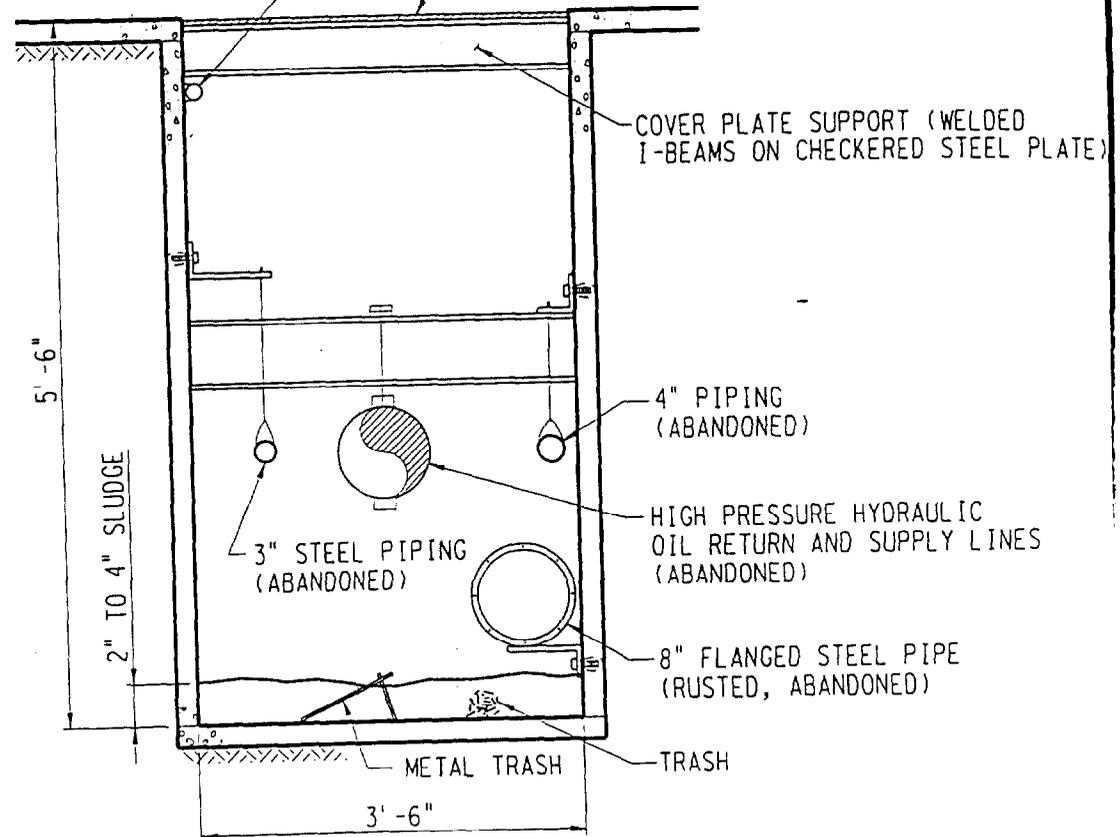
Figure I-5  
Typical Section Through Pipe Chase  
Before Remedial Action

8" FLANGED STEEL PIPE  
(RUSTED, ABANDONED)

1. RUST ON ALL COMPONENTS.
2. SEE GENERAL LOCATION ON FIGURE I-3.

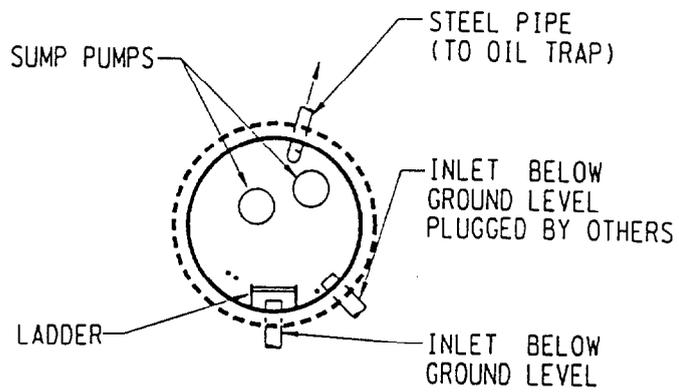
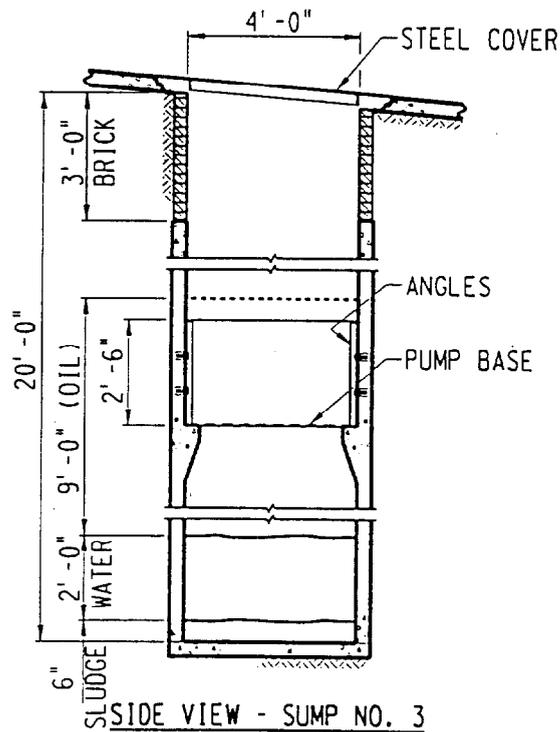
Figure I-8  
Sump 3 Before Remedial Action

1. RUST WAS PREVALENT ON ALL METAL COMPONENTS.
2. BRICK WAS DETERIORATED.
3. STEEL ACCESS LADDER WAS RUSTED.
4. SUMP PUMPS, LADDER, ELECTRICAL CONDUITS WERE NOT SHOWN IN THE SECTION FOR CLARITY.
5. SEE GENERAL LOCATION ON FIGURE I-3.

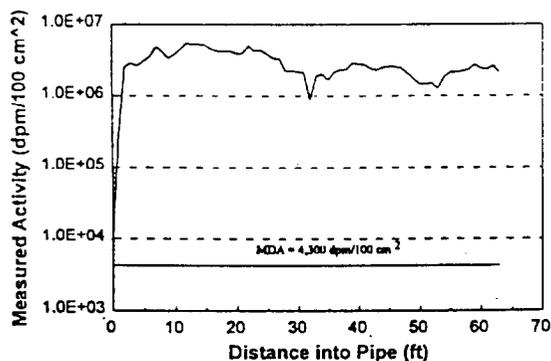
**Figure 4. Surface activity measured in a 4-inch drain-line at the FUSRAP site with the manually operated Pipe Explorer™ system. These measurements were taken prior to removal of contaminated sludge from the drain-line.**

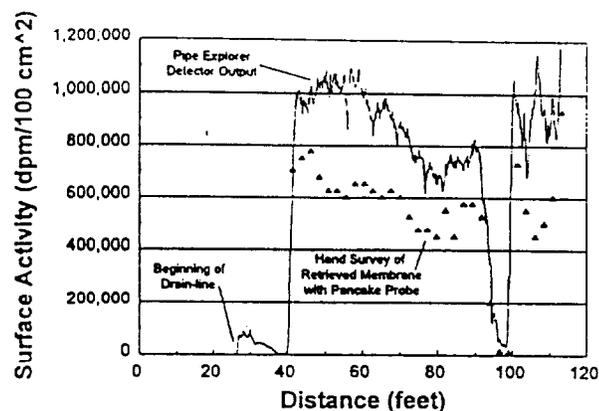
of this length to guide the membrane to the drain-line entrance. The structure of this data shows the utility of a continuous survey. The data shows a small amount of contamination up to the 40-foot mark in the drain-line. At this point the line intersects another drain-line which had been thoroughly cleaned. After the intersection, however, substantial contamination was encountered. The only exception was a relatively clean section between 90 and 100 feet.

Figure 6. Survey of a drain-line at the FUSRAP site with the automated Pipe Explorer™ system (solid line). Triangular data markers show measurements of contamination on the membrane retrieved from the drain-line.

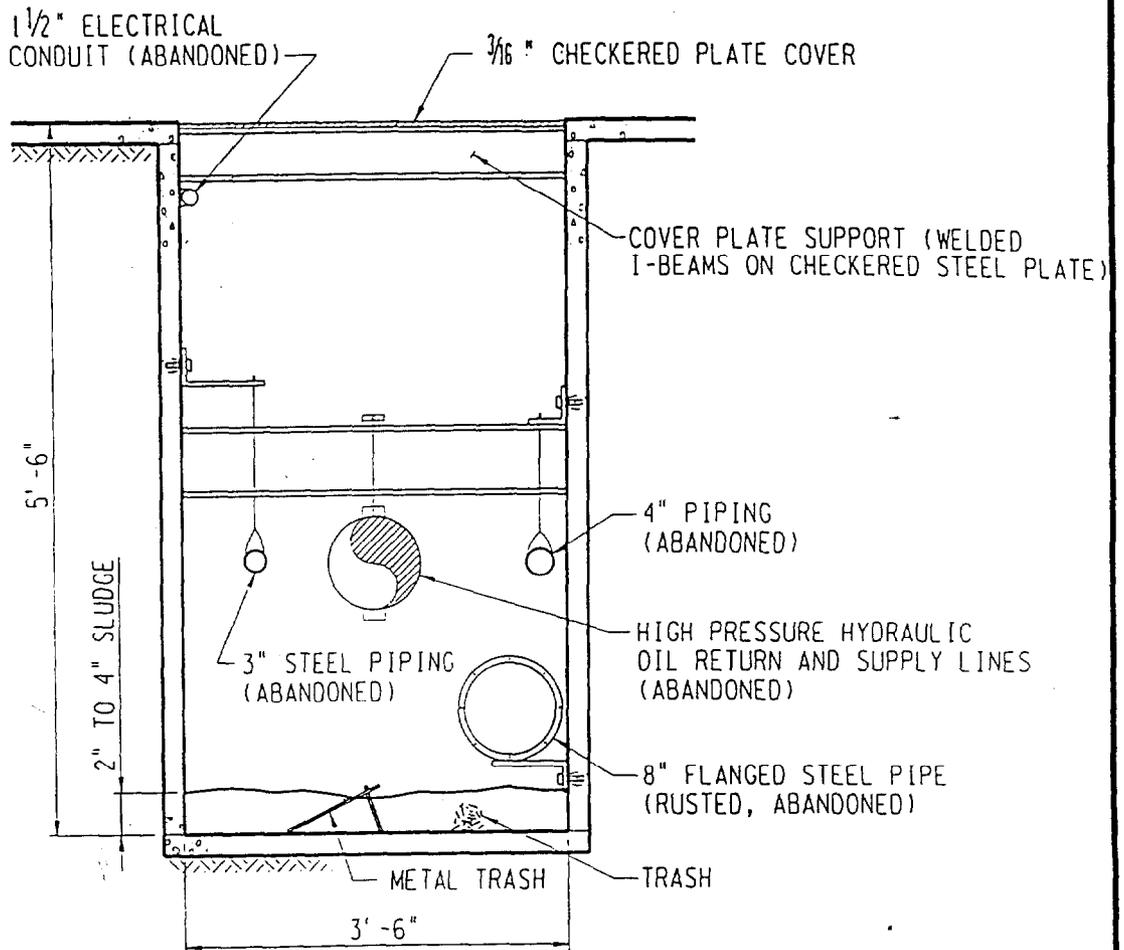
**Figure III-5**  
 Typical Section Through Pipe Chase  
 Before Remedial Action

1. RUST ON ALL COMPONENTS.
2. SEE GENERAL LOCATION ON FIGURE I-3.

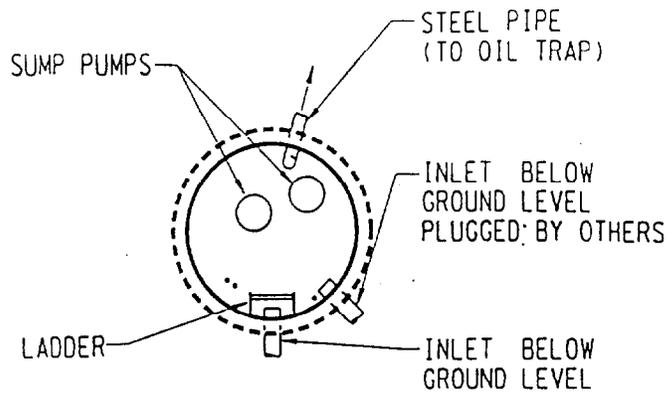
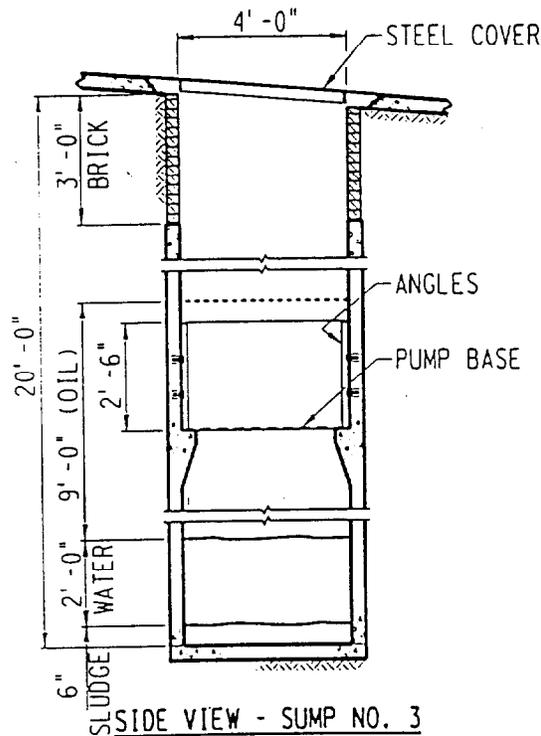
1. RUST WAS PREVALENT ON ALL METAL COMPONENTS.
2. BRICK WAS DETERIORATED.
3. STEEL ACCESS LADDER WAS RUSTED.
4. SUMP PUMPS, LADDER, ELECTRICAL CONDUITS WERE NOT SHOWN IN THE SECTION FOR CLARITY.
5. SEE GENERAL LOCATION ON FIGURE I-3.
